NASA CR-165664

Advanced Composite Aileron For L-1011 Transport Aircraft-- Ground Tests And Flight Evaluation

C.F. Griffin

Lockheed Corporation
Lockheed-California Company
Post Office Box 551
Burbank, California 91520

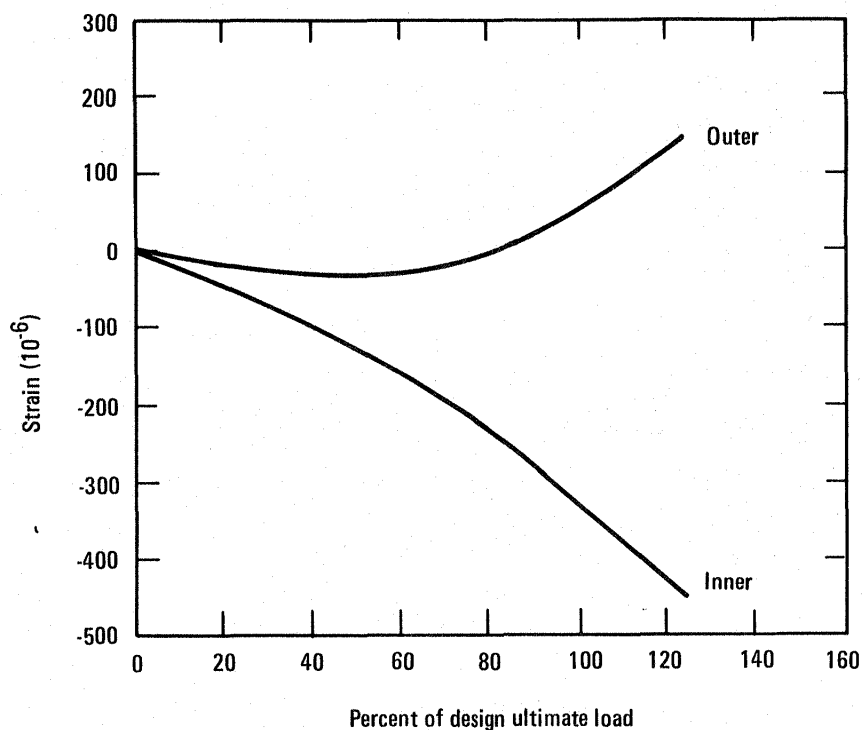
Figure 15. - Condition 4, upper cover strains at I.A.S. 85.7.

Analysis indicated that for the Condition 4 loading the upper cover would buckle in compression at 24 percent of DUL. This behavior is illustrated on figure 15 which displays the spanwise strains in the inner and outer surface of the cover at I.A.S. 85.7. Buckling occurred at approximately 70 percent of DUL.

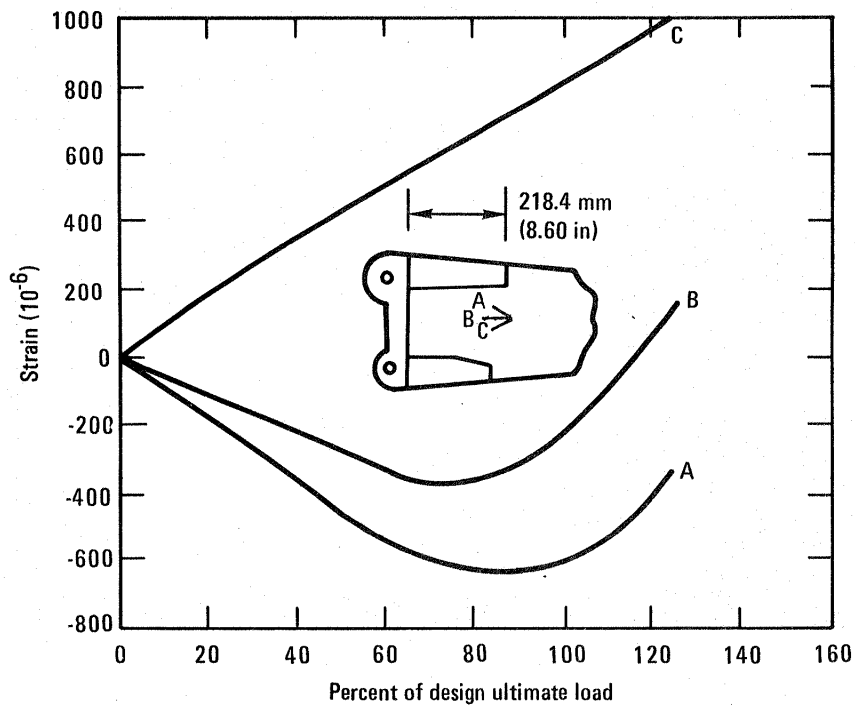
Figure 18. - Condition 4, I.A.S. 102.7 rib web strains at page 23.

The back-to-back strain rosette data for the hinge/actuator rib web at I.A.S. 102.7 are shown on figures 18 and 19. These rosettes, located 218.4 mm (8.6 in) aft of the front spar web, indicate the initiation of rib web buckling at 90 percent of DUL.

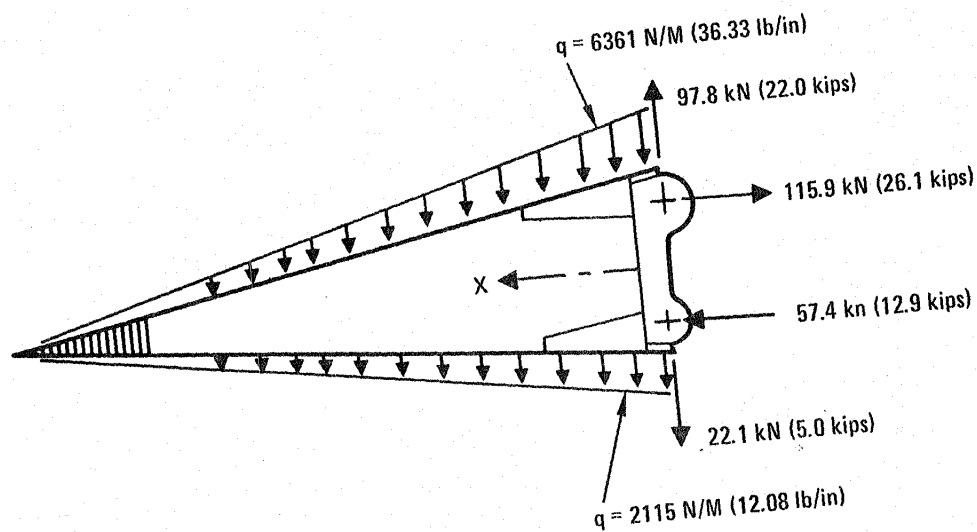
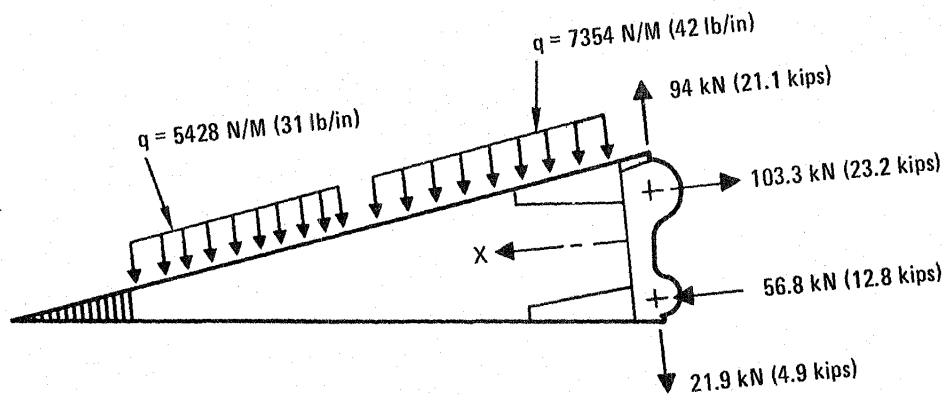
Figure 25. - Comparison of design loads to test loads for I.A.S. 102.7 rib.

As illustrated on figures 25 and 26 the results of the rib analysis show that the rib loads applied in the test were equivalent to those applied by the flight loading condition. Based on this analysis the predicted failure load for the rib web (using room temperature, dry average material properties) was 126 percent of design ultimate load.
